# Manhole Inspection Summary

Manhole # S35WW1017MH

Insp Date: 1/31/07 1:21 PM

**Location** Address: **5208 TILBURY WAY**

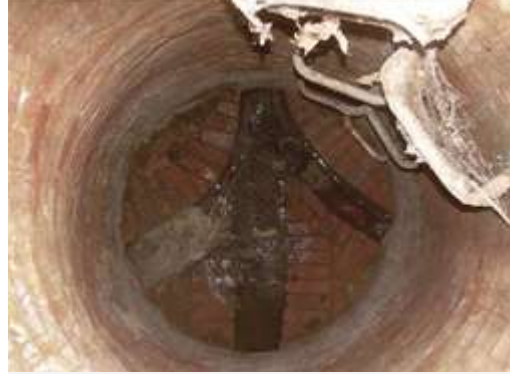
Top View

Corroded steps. Bench and Channel debris.

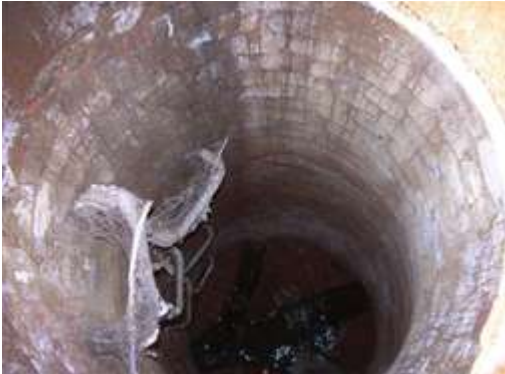
Defect

Adjustment deterioration and infiltration. Barrel infiltration.

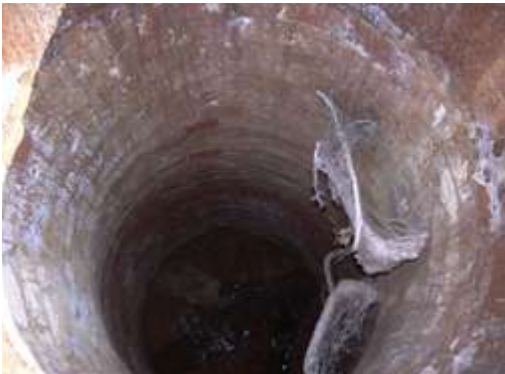
Defect

Adjustment deterioration and infiltration. Barrel infiltration - other side.

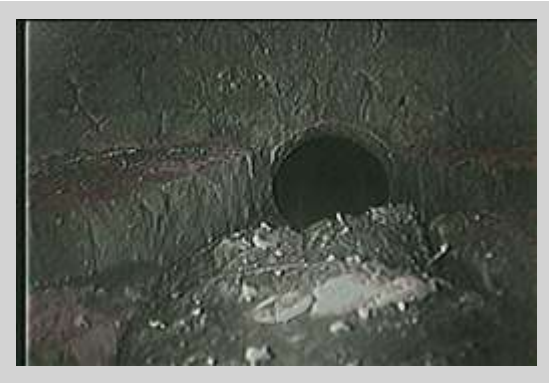
### 8 in. Circular Gravity Sewer Pipe Out @ 12 O'Clock

Barrel deterioration and infiltration.

Infiltration: **Evidence** Pipe Seal Cond: **Unknown**

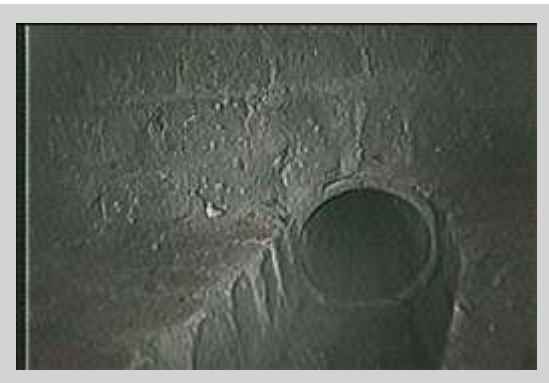
### 6 in. Circular Gravity Sewer Pipe In @ 3 O'Clock

Infiltration: **Evidence** Pipe Seal Cond: **Unknown**

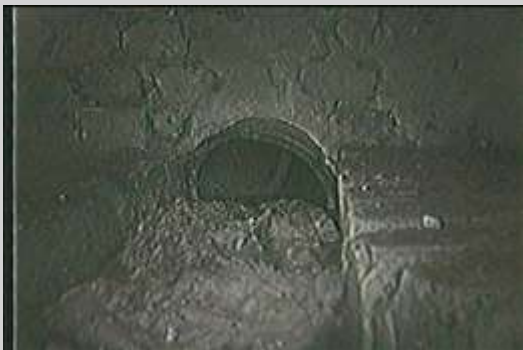
Pipe In @ 8 O'Clock

Deposits: ☐ None ☒ **Mud** ☐ Sludge ☒ **Debris** ☐ Grease

Silt Depth: **3** (in.) Deposits Extent: **Medium**

Infiltration: **Evidence** Pipe Seal Cond: **Unknown**
